AMESBURY ACADEMY
71 Friend Street, Amesbury, MA
2021 ASBESTOS 3 YEAR REINSPECTION

RPF File 21.0880

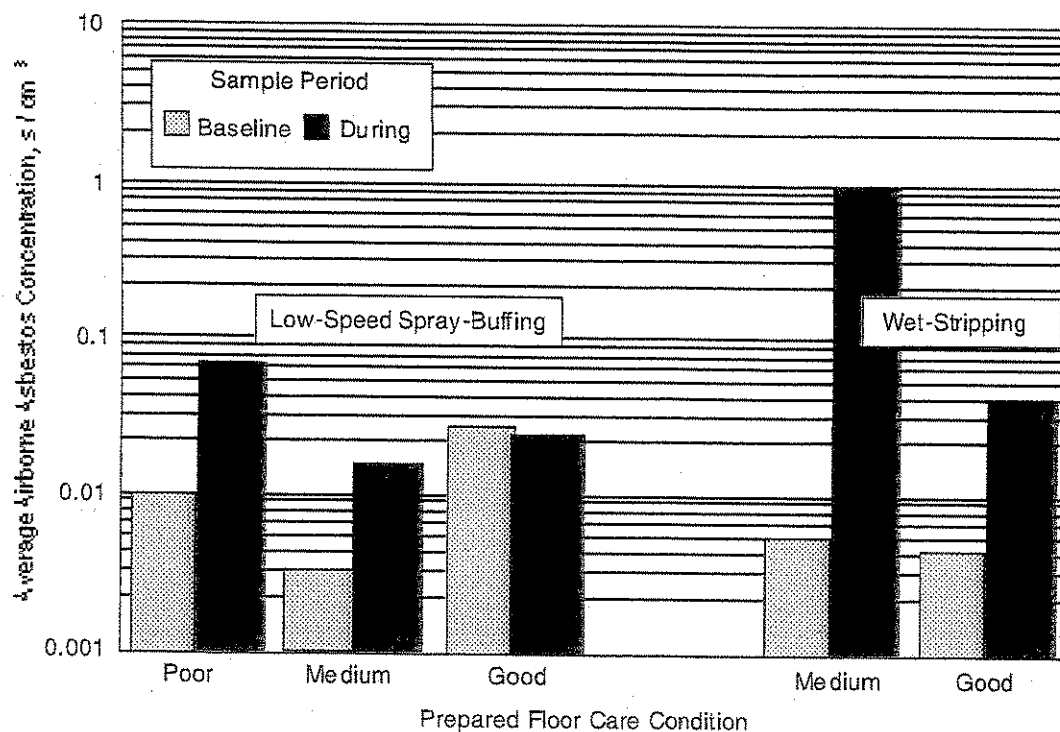
Figure 1 illustrates the overall average (geometric mean) concentrations measured before and during low-speed spray-buffing and wet-stripping on floors in prepared floor conditions. Although the mean relative increase in airborne asbestos concentrations during low-speed spray-buffing tended to decrease as the floor care condition improved (i.e., poor condition resulted in a larger relative increase than medium, and medium condition showed a larger relative increase than good), the differences between the three levels of floor care were not statistically significant ($p=0.1149$). Overall, the average airborne asbestos concentration during low-speed spray-buffing was approximately 2.6 times higher than the average baseline concentration. This increase was statistically significant ($p=0.0017$). A 95% confidence interval for the mean airborne asbestos concentration during spray-buffing as a proportion of the baseline concentration showed that the overall mean airborne asbestos con-

Figure 1. Average airborne asbestos concentrations during low-speed spraying of floors in prepared conditions.

- 2) The average airborne asbestos concentration measured during low-speed spray-buffing of floors in the three levels of prepared floor-care conditions (poor, medium, and good) was approximately 2.6 times higher than the average baseline concentration. This increase was statistically significant.
- 3) The level of prepared floor care did not significantly affect the airborne asbestos concentrations measured during low-speed spray-buffing. Although the average increase in airborne asbestos concentrations tended to decrease as the level of floor care improved, the differences due to the three levels of floor care were not statistically significant.
- 4) Wet-stripping of floors in medium and good condition (after low-speed spray-

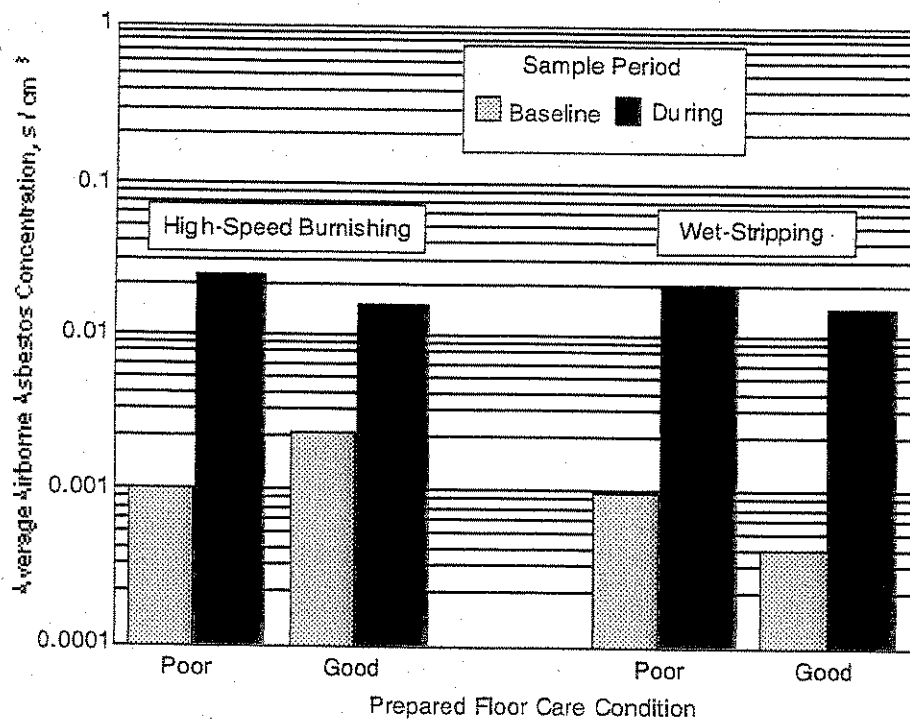
Figure 2. Average airborne asbestos concentrations measured before and during ultra high-speed burnishing and wet-stripping of floors in prepared conditions.

TWA concentrations measured during wet-stripping (after ultra high-speed burnishing) exceeded the OSHA PEL of 0.1 f/cm³ for total fibers, all of the 8-hr TWA concentrations measured during ultra high-speed burnishing exceeded the OSHA PEL. These exceedances, however, were due to the excess nonasbestos-containing particulate generated during the burnishing process and not to elevated airborne asbestos particles.
